**Coastal Changes,
Eastern Lake Michigan, 1970-74**

William A. Birkemeier

MISCELLANEOUS REPORT NO. 81-2

**U.S. ARMY, CORPS OF ENGINEERS
COASTAL ENGINEERING
RESEARCH CENTER**

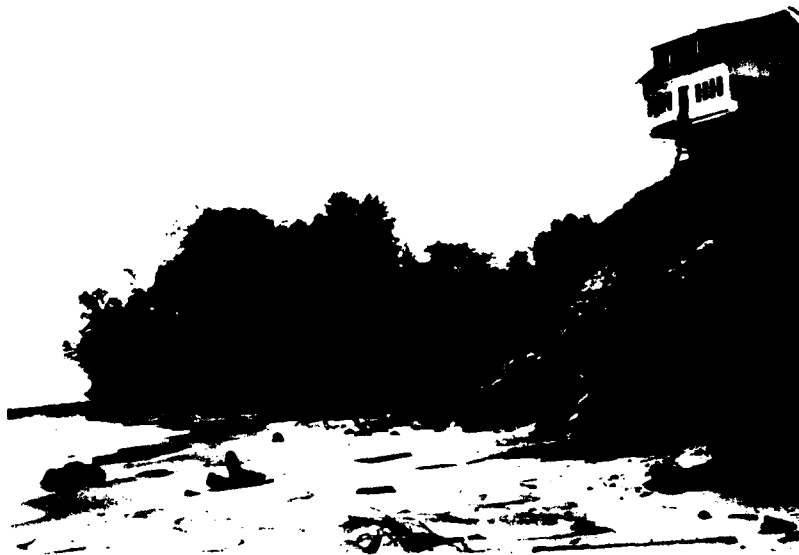
Figure 1. Severe bluff erosion undermining lakefront home near Stevensville, Michigan (17 October 1976).

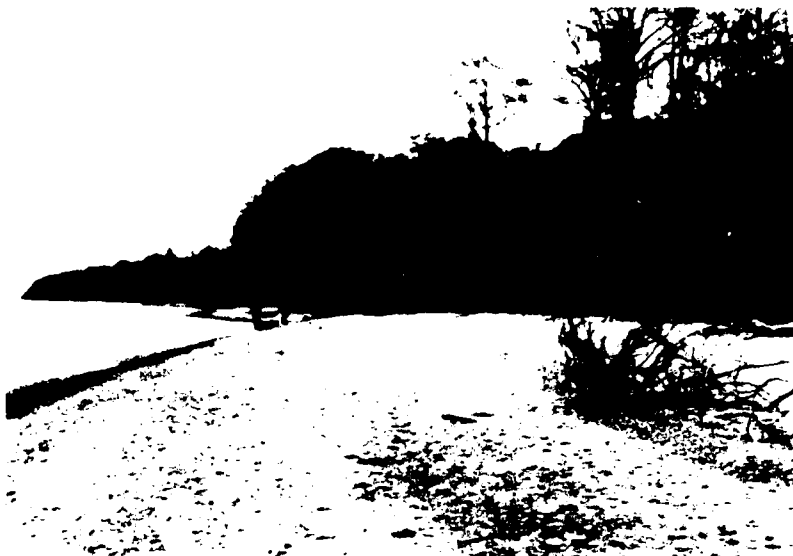
8 May 1973 - View north toward the profile line. Note width of beach in foreground and indentation near surveyors.

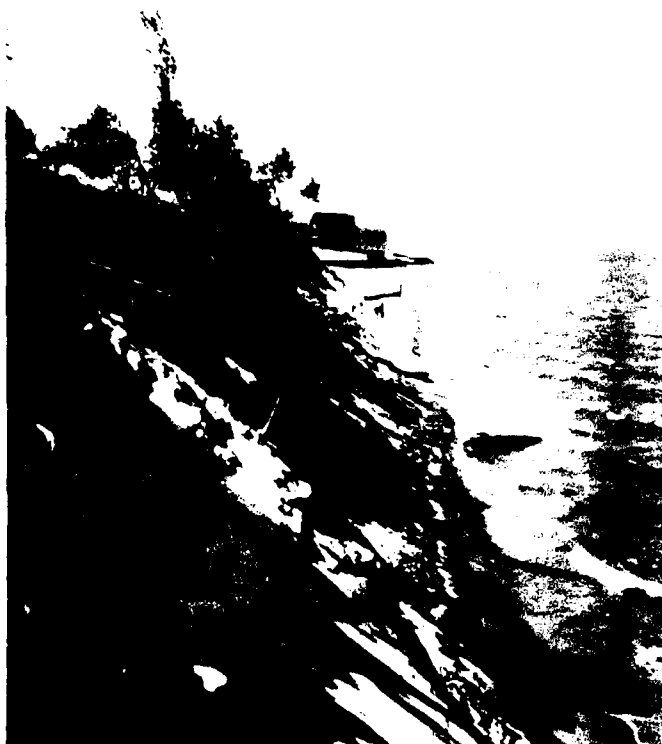
8 May 1976 - Similar view as above but 3 years later. Beach is narrow or non-existent; bluff is steep and recently eroded.
